BOMB CRATER REPAIR TECHNIQUES FOR PERMANENT AIRFIELDS

Report I

SERIES I TESTS

David L. Cooksey

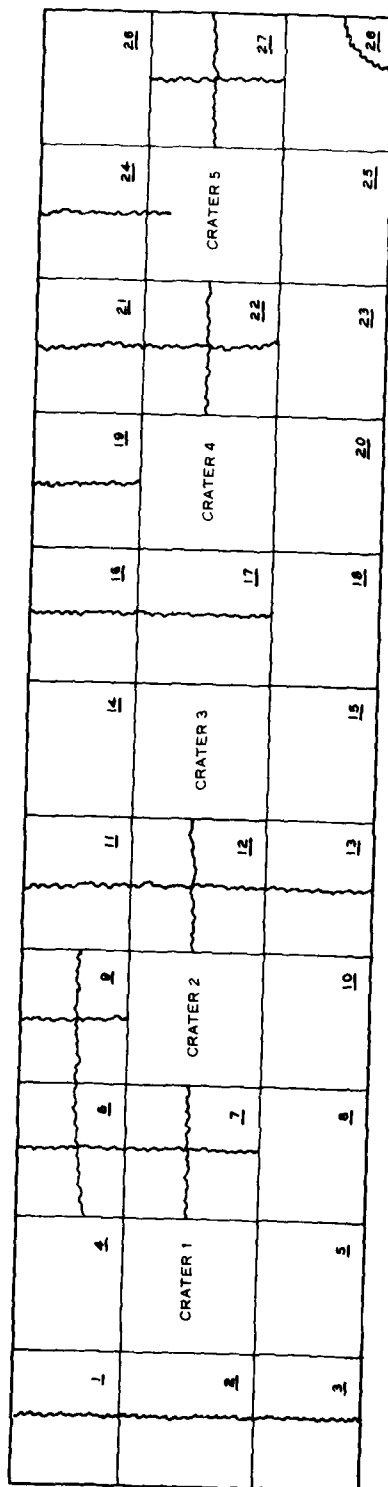
Figure 17. Cracks in concrete prior to asphalt overlay

45. The concrete, upon curing, developed some minor cracks. The south lane contained transverse cracks with one slab, No. 28, containing a corner crack (Figure 17). All slabs in the center section contained transverse cracks, and three contained longitudinal cracks. Seven of the slabs in the north lane contained transverse cracks and two of these also contained longitudinal cracks. In some instances, the transverse cracks continued across two or even three slabs in a seemingly continuous line. All cracks were considered to be shrinkage cracks.

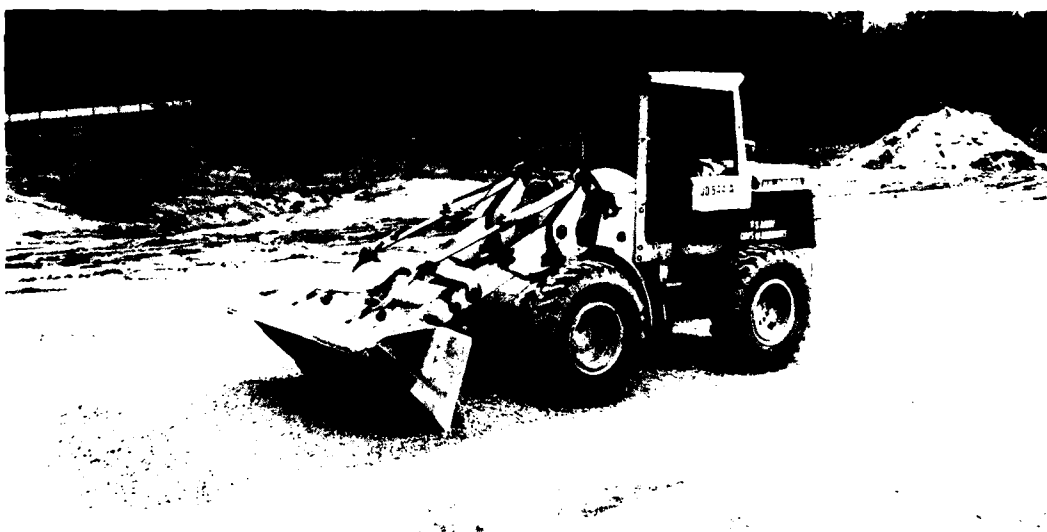
Photo 70. Maintenance being performed on limestone repair in crater 1

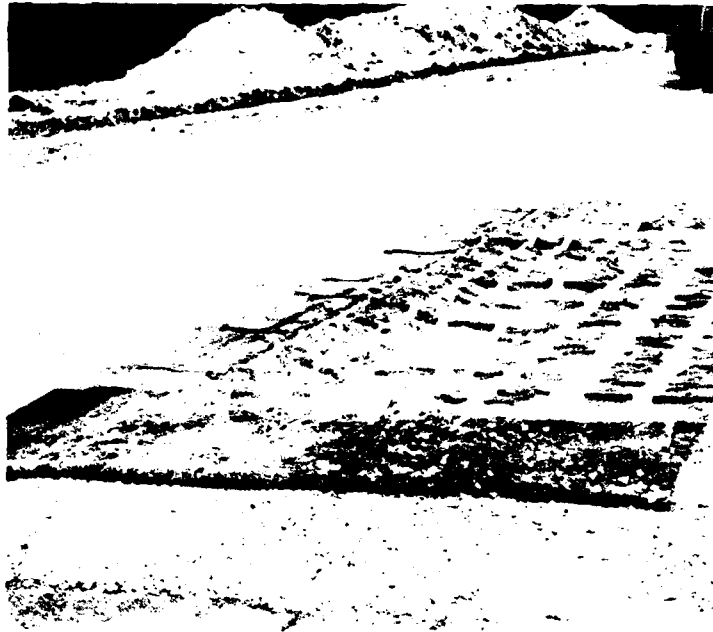
Photo 83. End of fabric rolled back to show condition of bottom surface after loss of bond

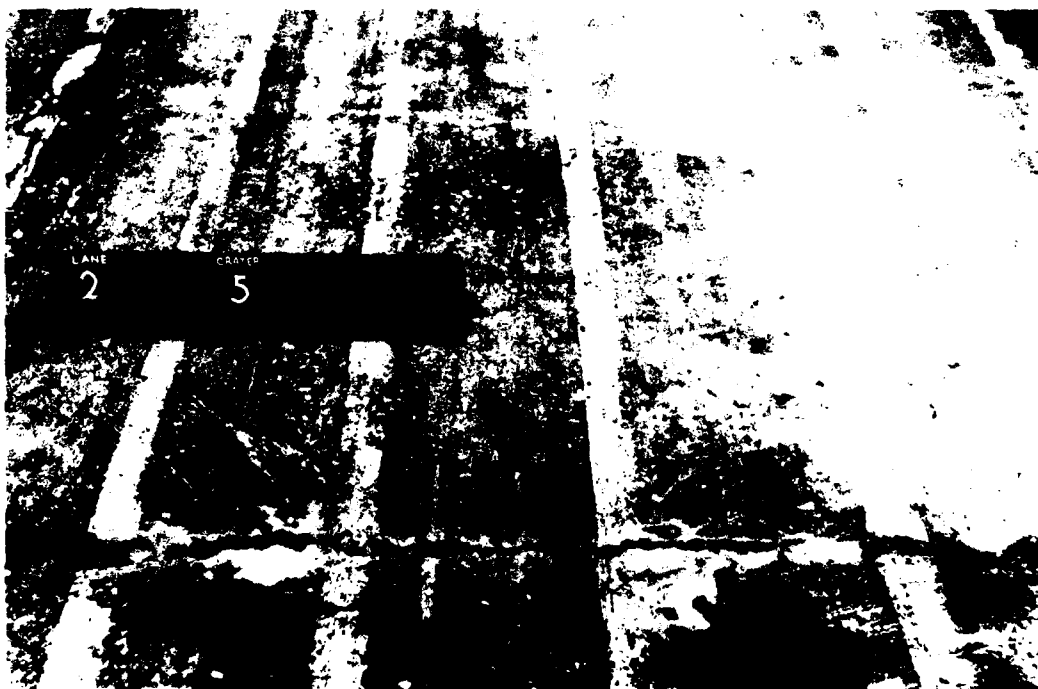
occurred after 5100 passes of traffic and only minor spalling was evident (Photo 125). A test pit in this area revealed a hairline crack in a concrete moment transfer device near the crater face which allowed the pumping of subgrade material. Otherwise, the moment transfer appeared to have no other structural damage. Profile and cross-section data indicated very little change in elevation (Figures 10 and 15).

Photo 124. Subgrade material pumping at corner of crater 5, lane 2, after 3876 passes of C-141 traffic

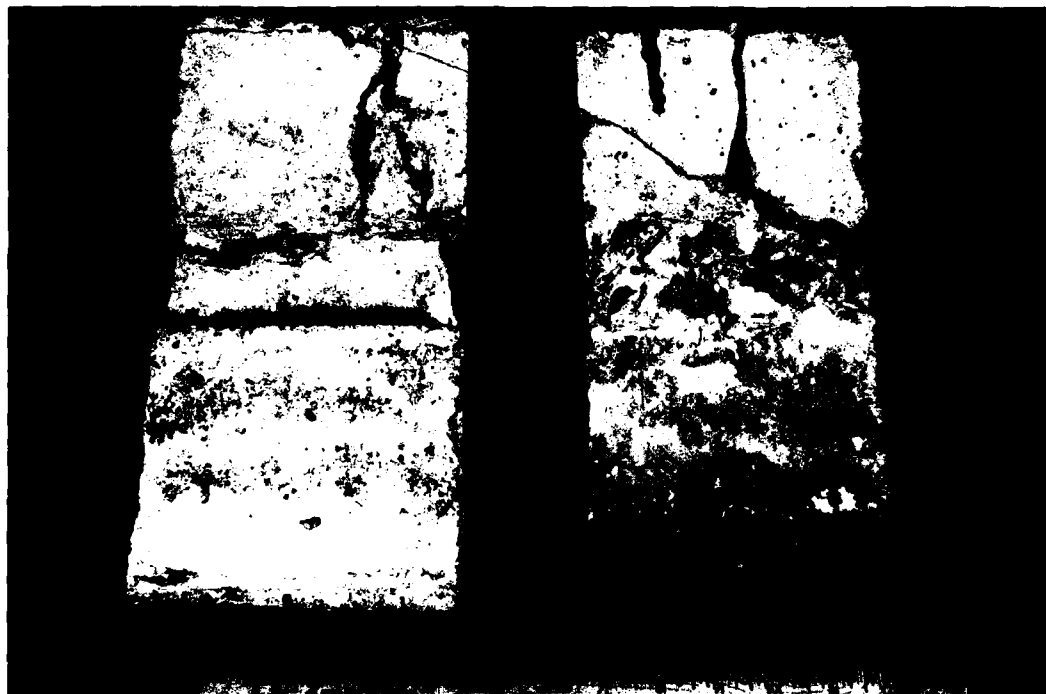
Photo 133. Cross section of concrete core taken through
keyed joint showing failure of male portion of key
